**VERIDIAN ON-SITE SIDE IMPACT AIR BAG INVESTIGATION
VERIDIAN CASE NO. CA98-023
VEHICLE: 1998 CADILLAC DeVILLE
LOCATION: FLORIDA
CRASH DATE: MARCH 1998**

1. <i>Report No.</i> CA98-023	2. <i>Government Accession No.</i>	3. <i>Recipient's Catalog No.</i>	
4. <i>Title and Subtitle</i> Veridian On-Site Alleged Inadvertent Air Bag Deployment Investigation Vehicle: 1998 Cadillac DeVille Location: Florida		5. <i>Report Date:</i> October, 1999

14. <i>Sponsoring Agency Code</i>	
15. <i>Supplementary Notes</i> On-site investigation of a side impact air bag deployment crash that resulted in death to the 74 year old female front right passenger.

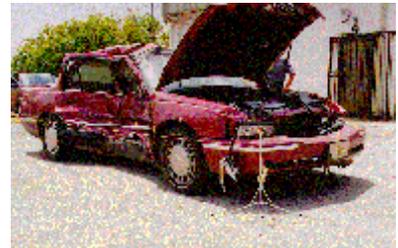
Figure 1. Overall view of the side impact damage to the Cadillac.

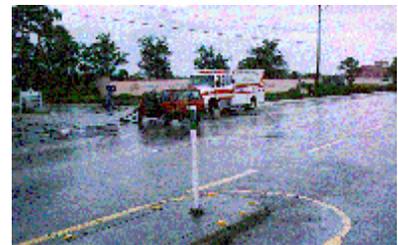
The driver of the Cadillac apparently detected the stopped Ford Probe and initiated a left turn across the southbound travel lanes into the hospital facility. It was unknown if the driver of the Cadillac failed to detect the approaching Jeep Cherokee or attempted to "beat" the vehicle across the intersection with the hospital driveway. As the Cadillac turned across the inboard right turn lane, the Jeep Cherokee impacted the right side of the Cadillac (**Figure 2**). The investigating police officer noted that there was no evidence of pre-crash braking from either vehicle on the wet asphalt road surface.

Figure 2. Left turn trajectory of the Cadillac and final rest of the Jeep Cherokee.

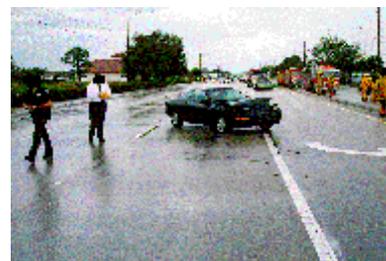
The left frontal area of the Cadillac subsequently impacted the center frontal area of the 1995 Ford Probe that was stopped on the inboard southbound through lane (**Figure 3**). The impact displaced the Probe rearward and rotated the vehicle in a counterclockwise direction. The center frontal impact sequence crushed the Probe's bumper to a maximum depth of 16.8 cm (6.6") and deployed the vehicle's frontal driver and passenger air bags. The damage to the Cadillac was minimal as the vehicle continued in a northeasterly direction. The 12 o'clock impact force to the Cadillac did not provide a sufficient longitudinal deceleration to deploy the vehicle's frontal air bag system. The SDM recorded a near deployment crash event for this impact sequence.

Figure 3. Subsequent trajectory of the Cadillac and impact with the Ford Probe.

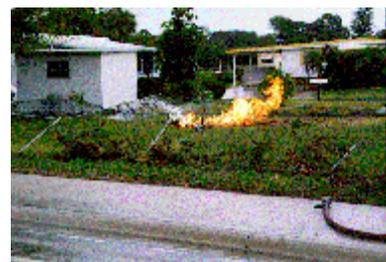
Figure 4. Continued trajectory of the Cadillac and impact with the fence and utility pedestal.

The Cadillac continued across a vacant mobile home site following the fence and shrub impacts. The frontal area of the vehicle impacted and overrode a utility pedestal that contained the electric, natural gas, and plumbing lines for connection to a mobile home. The impact fractured the PVC conduits which resulted in a gas leak and a subsequent fire of the venting natural gas (**Figure 4**).

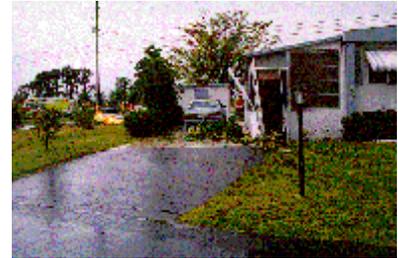
impacted the front corner of a aluminum addition attached to a mobile home. The left front corner impact resulted in sideswipe-type damage that extended the full length of the left side of the vehicle. Damage to the aluminum addition was minor (**Figure 5**).

Figure 5. Lookback view of the impact sequence with the mobile home.

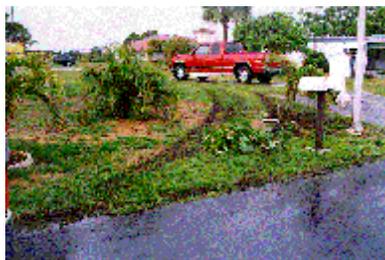
Figure 6. Acceleration marks across the lawn and subsequent impact with the pickup truck.

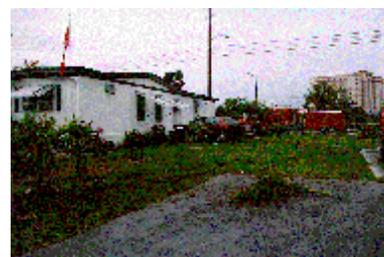
Figure 7. FRP of the Cadillac engaged against the mobile home.

The pickup truck impact redirected the Cadillac in a CCW direction as it traveled on a near perpendicular path into a large air conditioner unit positioned adjacent to a mobile home. The frontal impact sequence crushed the AC unit into the side of the mobile home as the Cadillac continued forward and impacted the sill area of the elevated mobile home. The vehicle penetrated into the side of the mobile home before coming to final rest (**Figure 7**). The total travel distance for the Cadillac from the initial point of impact with the Jeep Cherokee to final rest was approximately 152 m (500'). At rest, the engine of the Cadillac was stalled which probably resulted from the final impact sequence with the mobile home.

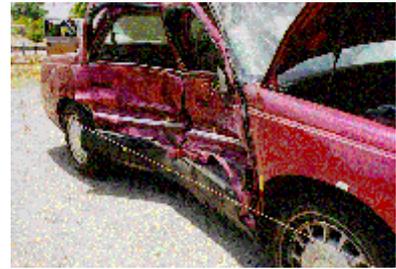
The Cadillac sustained severe right side damage (**Figure 8**) from its initial impact sequence with the Jeep Cherokee. Maximum crush was 63.5 cm (25.0") located at the rub strip level of the right front door, 22.2 cm (8.75") forward of the B-pillar. The direct contact damage began on the right front fender 43.2 cm (17.0") rearward of the right front axle position and extended 189.2 cm (74.5") rearward, ending on the right rear quarter panel 43.8 cm (17.25") forward of the rear axle. The combined induced and direct contact damage (Field L) began 33.0 cm (13.0") rearward of the right front axle and extended 263.5 cm (103.75") rearward to a point that was 33.0 cm (13.0") forward of the rear axle. Six equidistance crush measurements were documented along this profile at the level of the rub strip (mid door). The crush values were as follows: C1 = 0 cm, C2 = 0.75 cm (1.9"), C3 = 58.4 cm (23.0"), C4 = 63.5 cm (25.0"), C5 = 46.4 cm (18.25"), C6 = 0 cm.

Figure 8. Damage profile to the right side of the Cadillac.

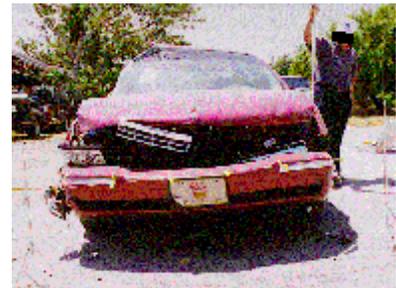
The frontal area of the Cadillac sustained moderate damage as a result of numerous impacts with two additional vehicles, two mobile homes, and five yielding objects (**Figure 9**). The direct contact damage was separated for several of the impacts, however, an overall crush profile was documented at the bumper level and the upper radiator support level. The direct contact damages were noted as follows:

Figure 9. Frontal impacts to the Cadillac.

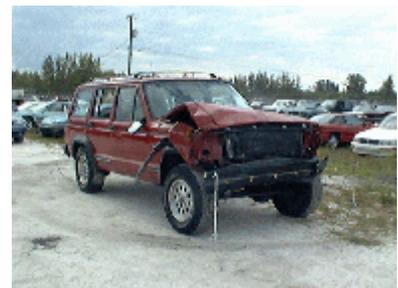
The 1992 Jeep Cherokee sustained moderate severity frontal damage (**Figure 10**) as a result of its impact sequence with the right side area of the Cadillac DeVille. The front bumper of the Cherokee was mounted directly to the front frame rails and a frame crossmember was positioned between the rails directly rearward of the bumper, therefore the frontal structure of the Cherokee was extremely rigid. The direct contact damage extended across the full width of the bumper and was 142.9 cm (56.25") in length. The crush profile at bumper level was as follows: C1 = 15.5 (6.1"), C2 = 10.2 cm (4.0"), C3 = 14.0 cm (5.5"), C4 = 11.7 cm (4.6"), C5 = 10.9 cm (4.3"), C6 = 28.6 cm (11.25").

Figure 10. Frontal damage to the Jeep Cherokee.

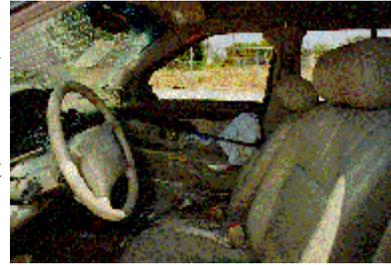
The interior of the 1998 Cadillac sustained severe damage that was associated with initial impact with the Jeep Cherokee. Additional damage resulted from deployment of the right side impact air bag and occupant contacts (**Figure 11**). The driver was properly restrained and loaded the manual belt system in response to the 2 o'clock impact force. His loading force against the belt webbing produced a D-ring transfer on the inboard aspect of the webbing. The transfer was located 34.3-37.5 cm (13.5-14.75") above the stop button for the latchplate. He subsequently rebounded into the left B-pillar. The driver's head impacted the adjustable D-ring assembly. The plastic housing for the D-ring was stressed and the adjustment button was fractured as a result of the contact.

Figure 11. Overall interior view of the intrusion, deployed side impact air bag, and occupants contact points.

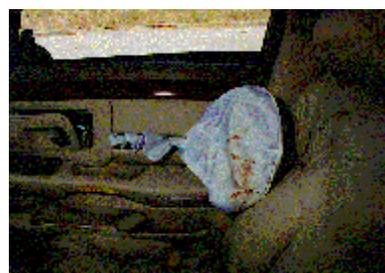
In addition to the frontal air bag system, this Cadillac was equipped with a side impact air bag system. The side impact air bags were available for the driver and front right passenger positions. The bags were mounted into the rear third aspect of the front door panels and were concealed behind symmetrical module cover flaps that were a padded component to the door panel (**Figure 12**).

Figure 12. Deployed right side impact air bag.

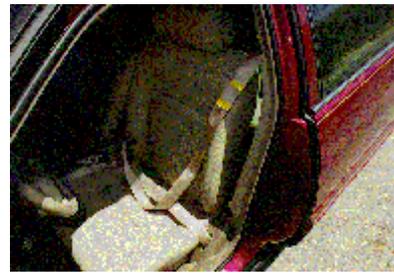
Both occupants of the Cadillac were properly restrained by the manual belt systems. Driver belt usage was determined from a D-ring transfer (Figure 13) that was noted to the inboard aspect of the webbing. The transfer was located 34.3-37.5 cm (13.5-14.74") above the latchplate stop button that located at the center point of the webbing. Routine usage of the driver belt system was evidenced by wear marks on the latchplate that was consistent with frequent usage for the recorded kilometers on the odometer.

Figure 13. Driver’s manual belt system with D-ring transfer on shoulder belt webbing.

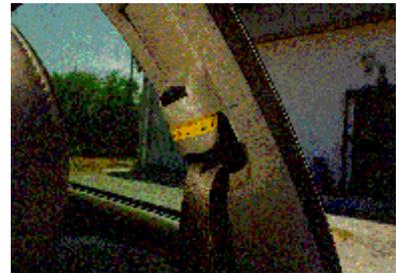
The driver subsequently rebounded across the interior of the vehicle. The posterior aspect of his scalp impacted the left adjustable D-ring assembly (**Figure 14**). The plastic adjustment panel was stressed from contact and the button was fractured. He sustained a concussion as a result of the contact, however, there was no loss of consciousness. The driver remained in the left front position of the vehicle with his right foot inadvertently depressed against the accelerator pedal and his hand(s) on the steering wheel assembly.

Figure 14. Driver rebound (head) contact to the right D-ring assembly.

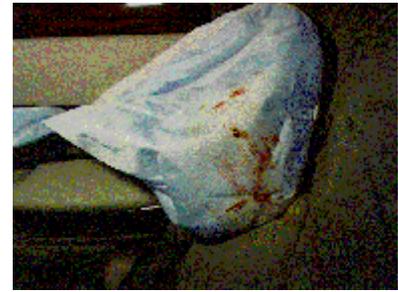
Occupant contact evidence on the side impact air bag consisted of a blood-like, patterned (cross-hatch) transfer that was located on the rearward face of the bag. The transfer was 16.5 cm (6.5") in height and 10.2 cm (4.0") horizontally. The cross-hatch pattern was similar in color and consistency to blood stains on the bag, however, the pattern was consistent with a fabric transfer. It was unknown if the transfer resulted from bag expansion against the passenger right arm (exposed tissue) or if the arm was protected by a sleeve, therefore resulting in a fabric transfer. None of the investigating officers were able to recall the type or color of clothing worn by the passenger on the day of the crash. Medical information did not identify an arm abrasion that would have resulted from this transfer pattern.

Figure 15. Crosshatch pattern on the side impact air bag.

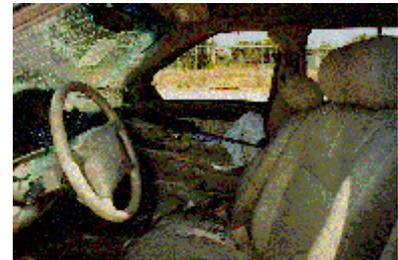
The deploying side impact air bag expanded against the right arm and right side of the female passenger. A patterned crosshatch transfer (**Figure 16**) which appeared to be dried blood or a reddish fabric transfer was noted to the face of the side impact air bag. This transfer resulted from air bag expansion against the clothing or exposed tissue of the passenger. There was no confirmation of a soft tissue arm injury, however, blood transfers were noted to the right front adjustable head restraint, seat back support, manual belt webbing, and the deployed side impact air bag.

Figure 16. Overall view of the passenger's position, belt usage, and deployed side impact air bag.

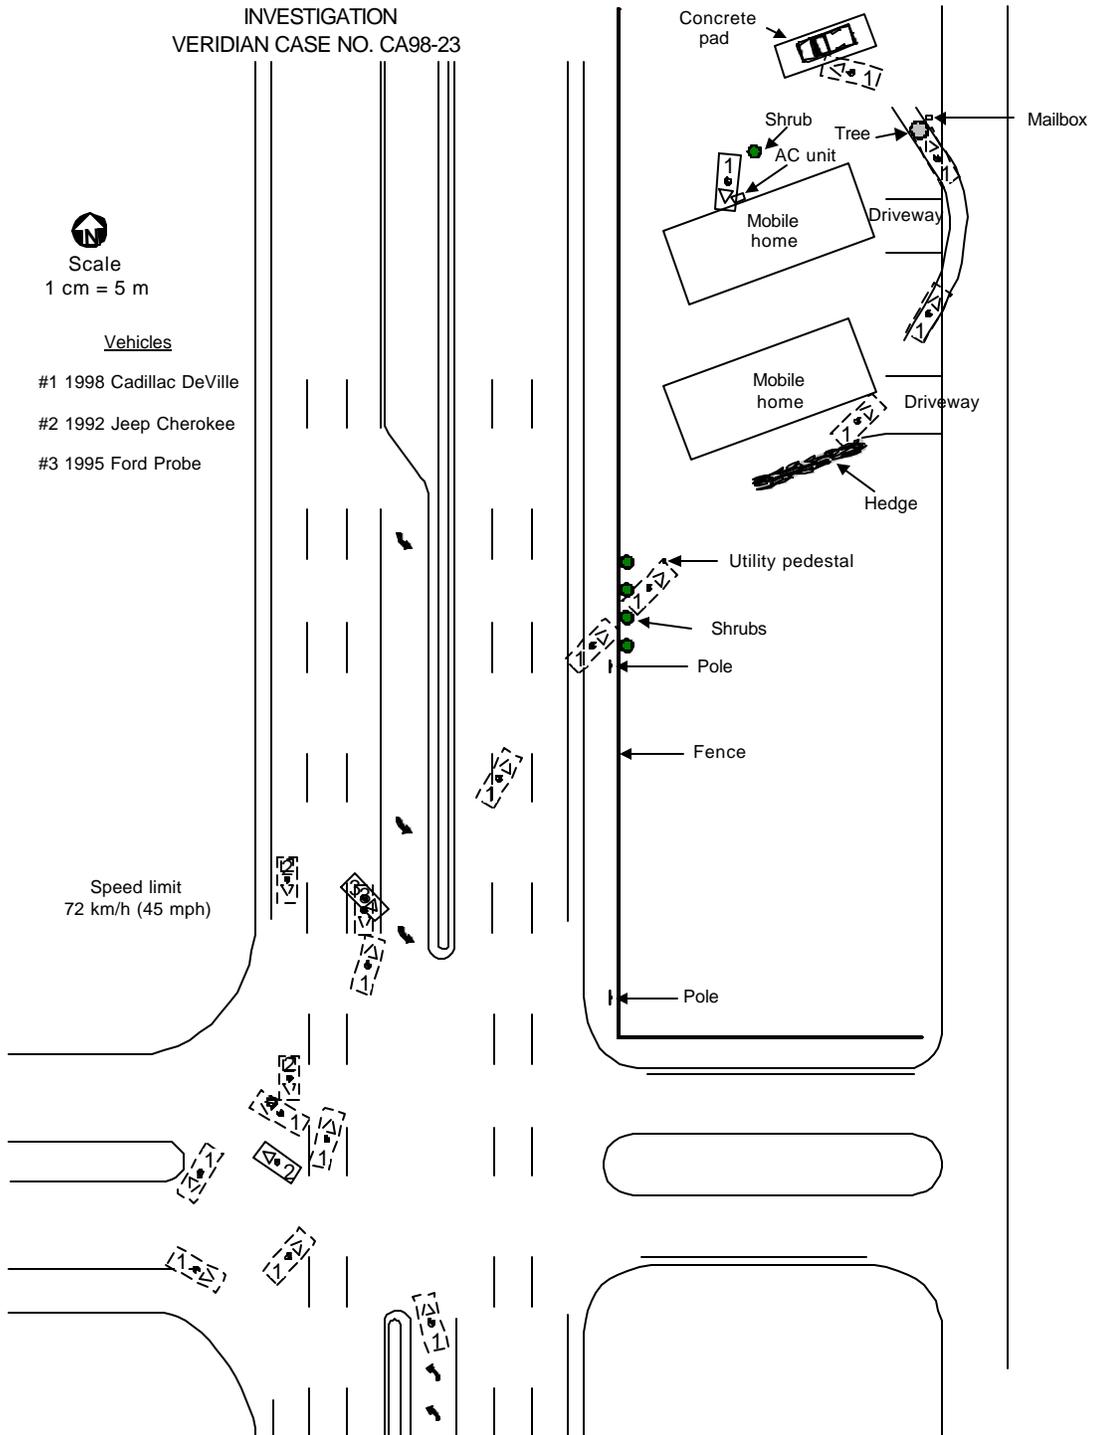
Figure 17. Crash schematic.

The state route consisted of three through lanes in the northbound direction of travel with a designated left turn lane and two through lanes for the southbound travel direction with designated left and right turn lanes. Marked bicycle lanes paralleled the outboard aspect of both travel lanes with barrier curbs separating the travel lanes from concrete sidewalks. The state route was straight and level and divided by a 1.1 m (3.7') curbed median. The asphalt road surface was wet due to rain with a posted speed limit of 72 km/h (45 mph). The ambient temperature was 19 degrees C (66 degrees F) with winds of 8 knots at 290 degrees. The crash schematic is attached as **Figure 17** on Page 17.
